# HIGH RESOLUTION SITE CHARACTERIZATION AND INTEGRATION WITH ENVIRONMENTAL FORENSICS: Case Study

*National Environmental Monitoring Conference  
Washington, DC*

**August 2017**

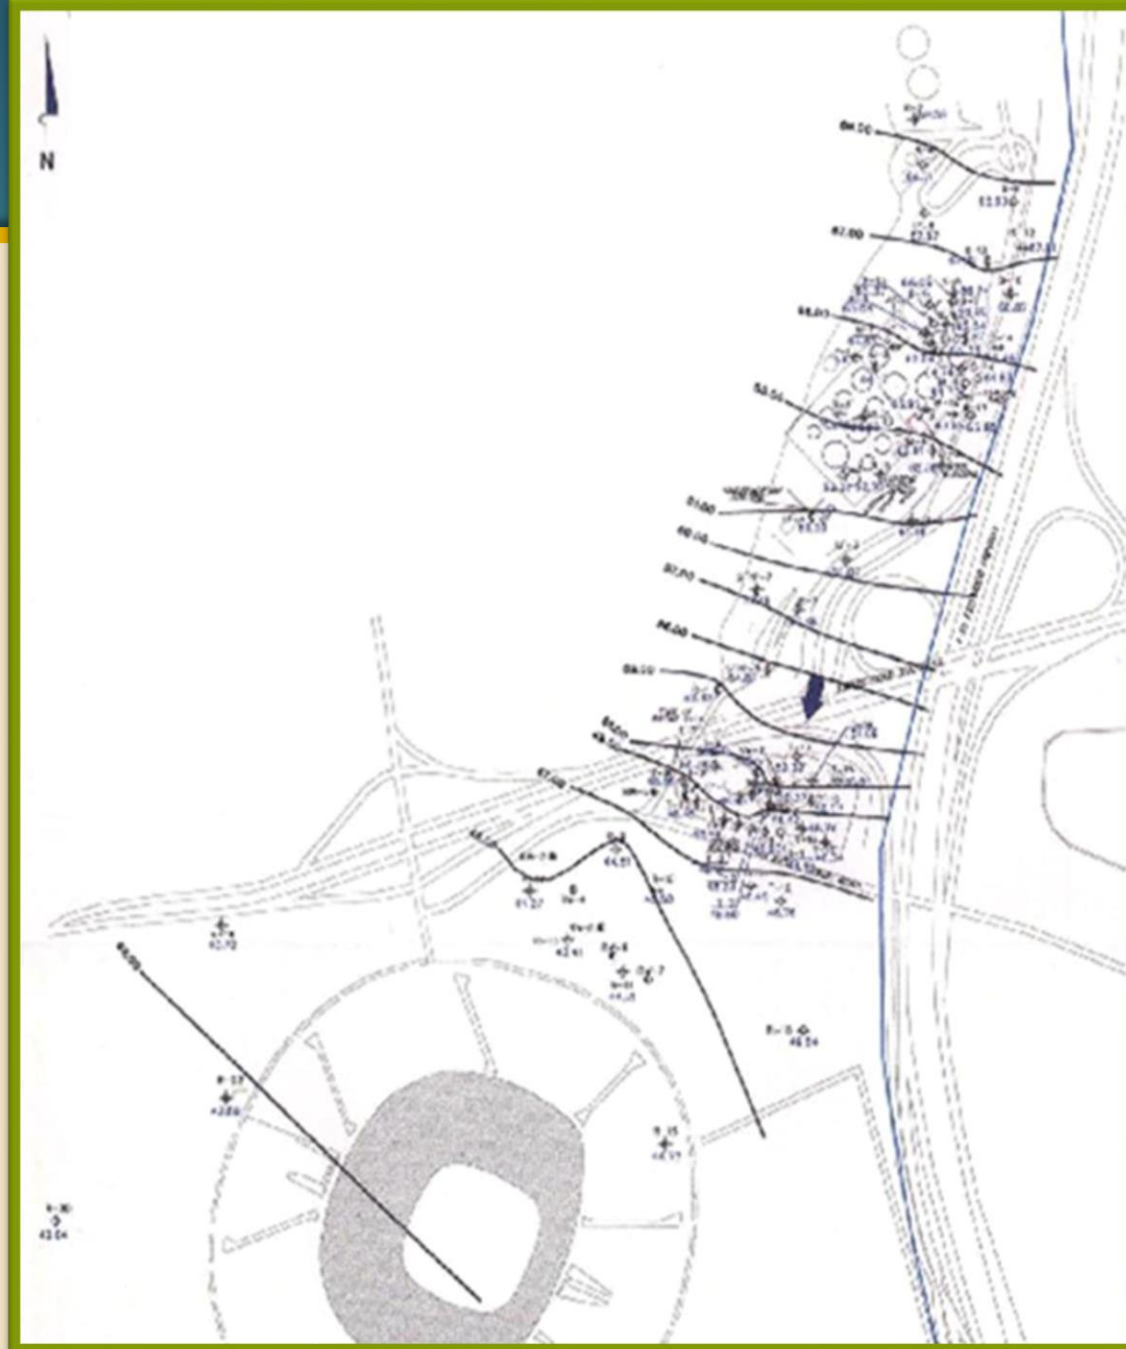
# GROUNDWATER FLOW DIRECTION

$V_{GW} = \sim 210 \text{ to } 750 \text{ m/year}$   
(determined through use of  
various pump and slug tests)

Southerly direction from the  
upper canyon area to the  
stadium parking lot with a  
westerly flow component  
once within the stadium  
area valley

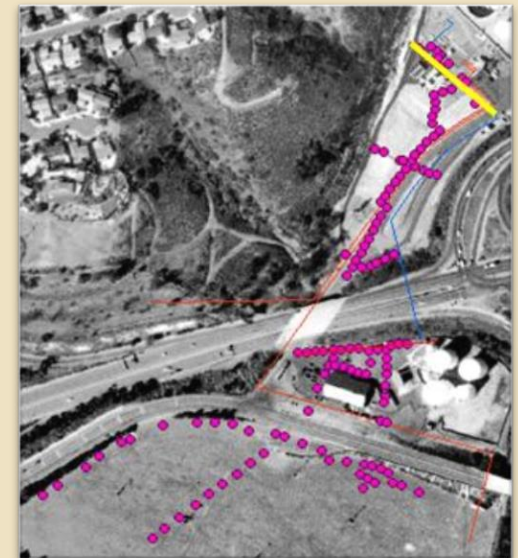
# CROSS SECTION A-A' LIF RESPONSE

MANIFOLD AREA

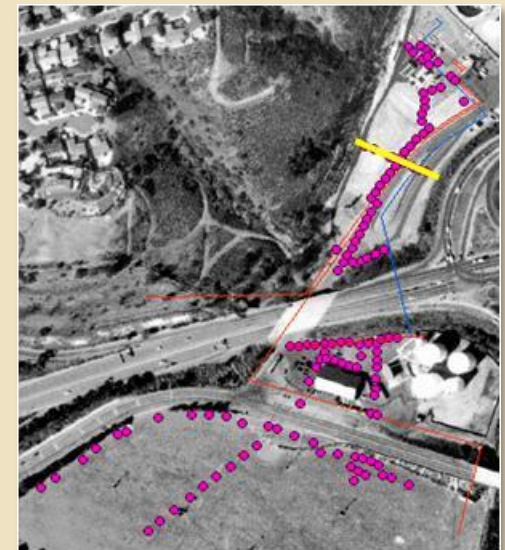
# CROSS SECTION B-B' LIF RESPONSE

## Downgradient from Manifold Area

- Elevated LIF responses concentrated along incoming/outgoing pipelines and in the area of the alleged gap.

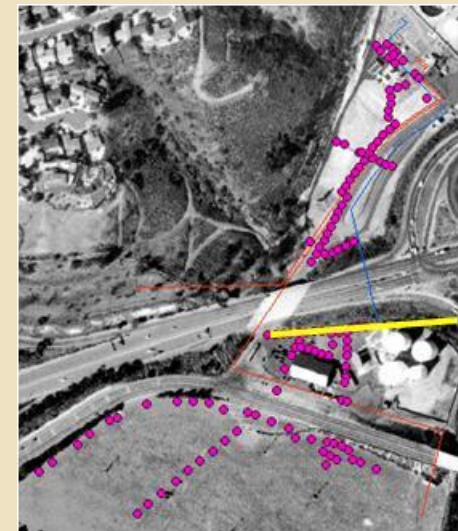
# CROSS SECTION C-C' LIF RESPONSE

**Lateral extent of core plume**

**North lower canyon facility boundary**

- **Small and isolated area in the operational area on the lower canyon facility.**
- **Same location of a documented diesel release.**

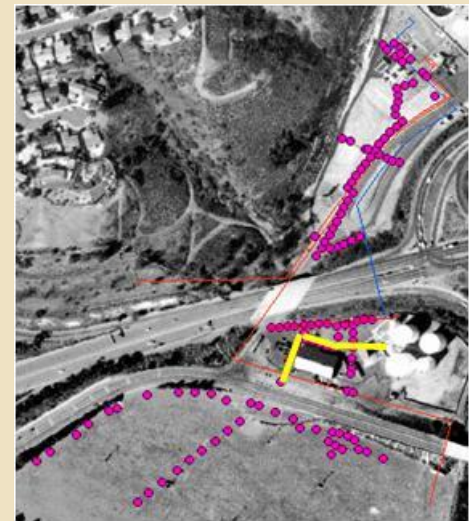
# CROSS SECTION D-D' LIF RESPONSE

Central lower  
canyon facility area

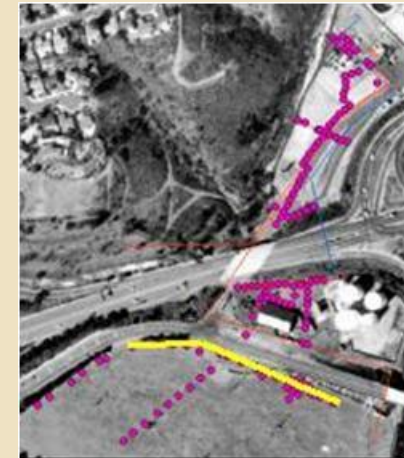
# CROSS SECTION E-E' LIF RESPONSE

North parking lot area

Two distinctly different plumes are defined by the LIF responses: A large continuous NAPL plume is present in the northern stadium parking lot with a smaller well-defined plume downgradient of the lower canyon operations area.
