# Reducing Remediation Costs and Environmental Impact by Addressing Hydrocarbon Contamination In-Situ and in Real-Time

The Combination of Real Time and In-Situ (in place)
Testing and Treatment of Hydrocarbon Contamination

NEMC 2018 - August 8, 2018 - New Orleans, LA By Charles D. Fator of Hanby Environmental and Randy Cook and Jessica Innocenti of OMG Solutions

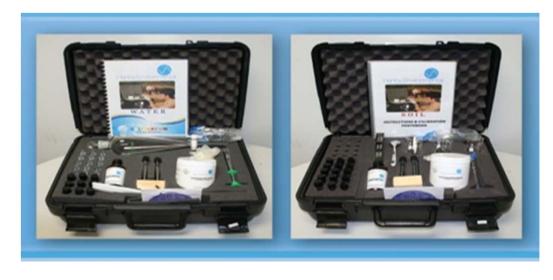
#### **TPH Test Kits for Soil & Water**

- Self contained kit contains everything to conduct 15 tests including color charts and instructional video.
- Refill sets of replacement reagents of 15 tests can be obtained to restock the test kits easily and quickly.

Kit type		TPH Contamination level
Water		0.1 – 200 PPM
Soil	Low Range	0 – 1000 PPM
	High Range	500 – 50,000 PPM

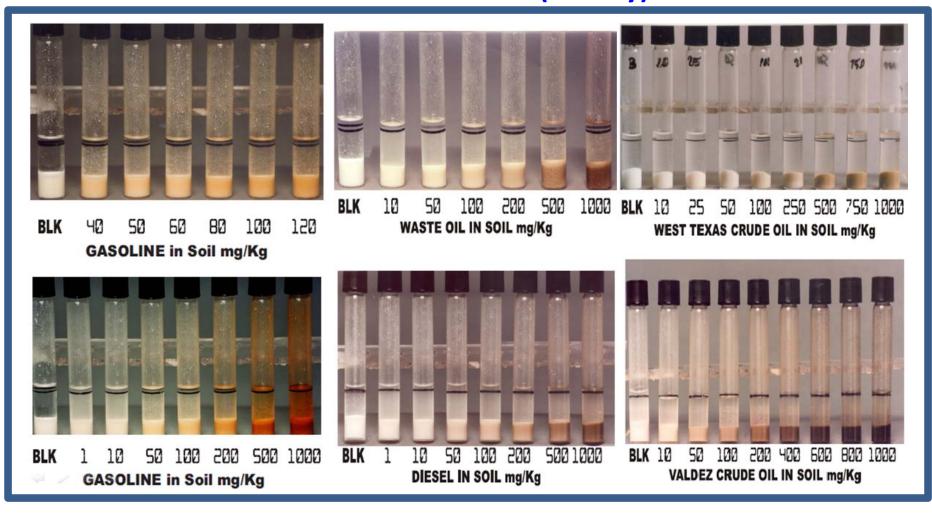
#### **Sample Soil Calibration Photos:**

The Kits Contain A Large Number of Calibration Photos (Library)

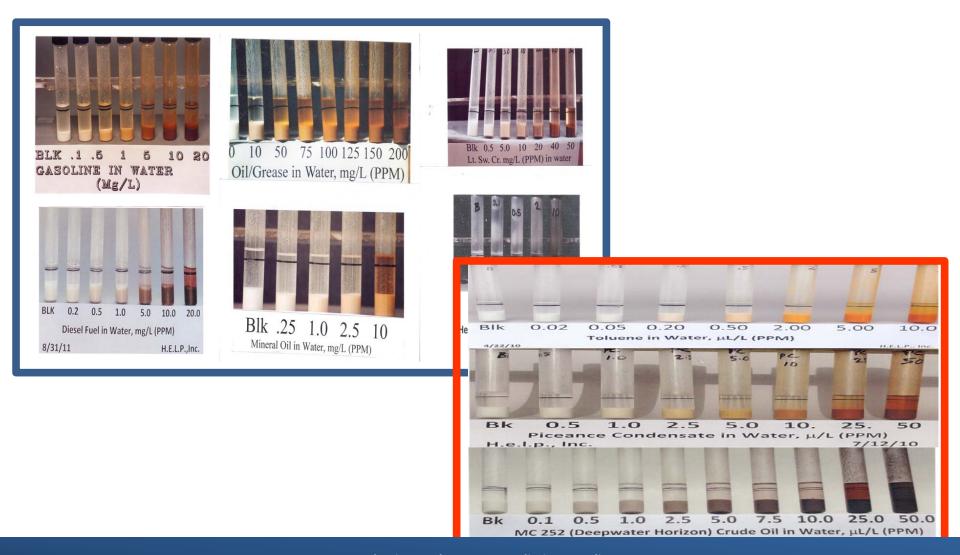
#### **Similar Water Calibration Photos:**

#### A Large Collection of Calibration Photos (Library)

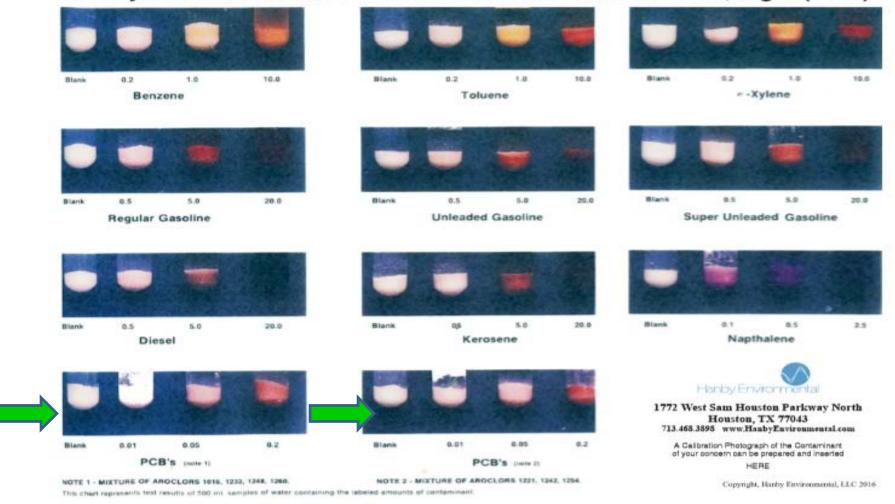
#### Similarly PCBs Are Detected in Water

Hanby Field Test Kit for Petroleum Contaminants in Water, mg/L (PPM)

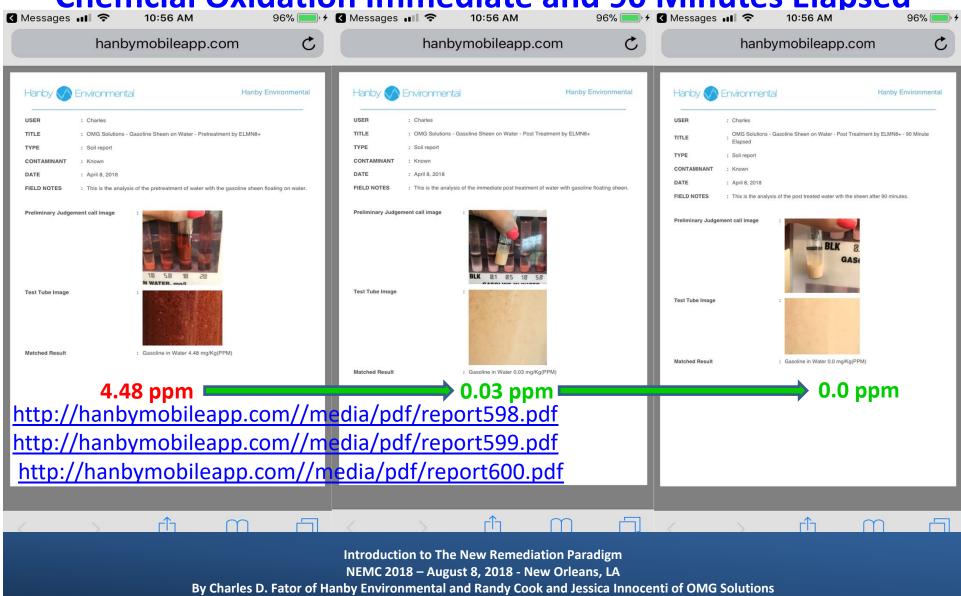
### Walk Thru Mobile App With Real Example Water with Gasoline Sheen Pre / Post Treatment by Chemcial Oxidation Immediate and 90 Minutes Elapsed

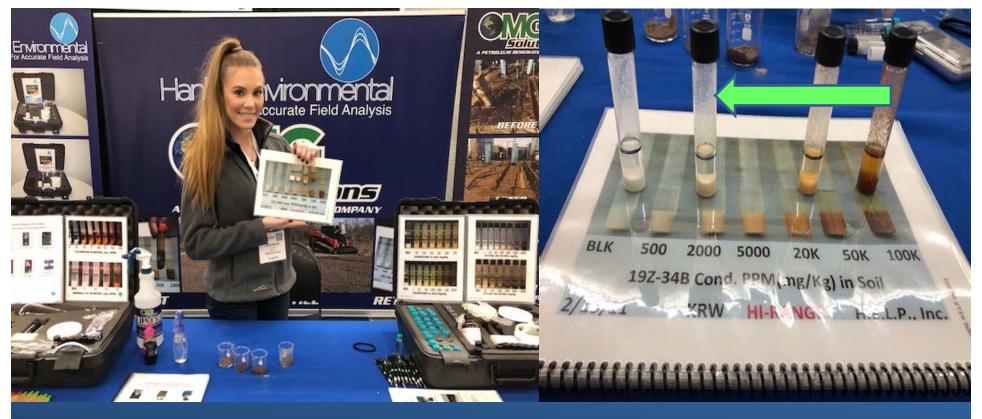
#### **Typical Soil Test Results:**

Clean Soil, Contaminated Soil to 125.5k ppm,
Reduced to 24.4k ppm,
Reduced to 1.1k ppm by Two Treatments

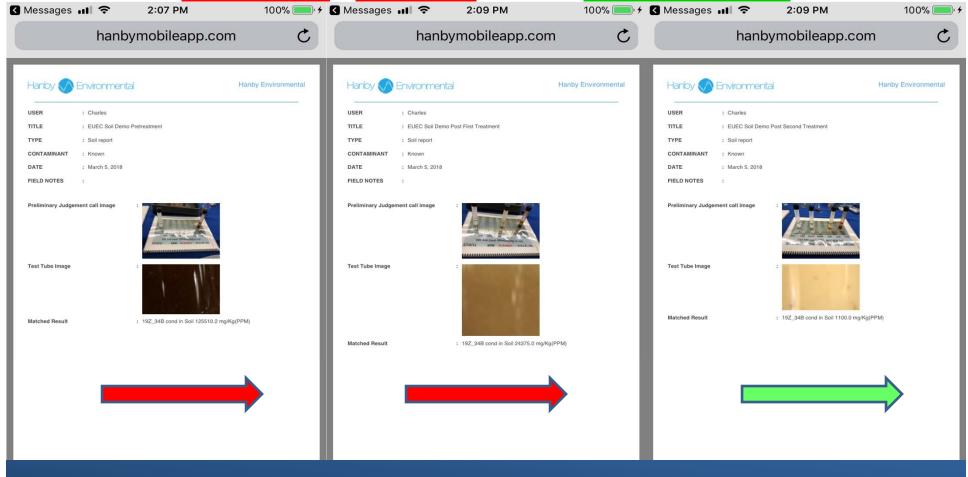
### Soil Treatment Validation Results

125.5k, 24.4k and 1.1k ppm

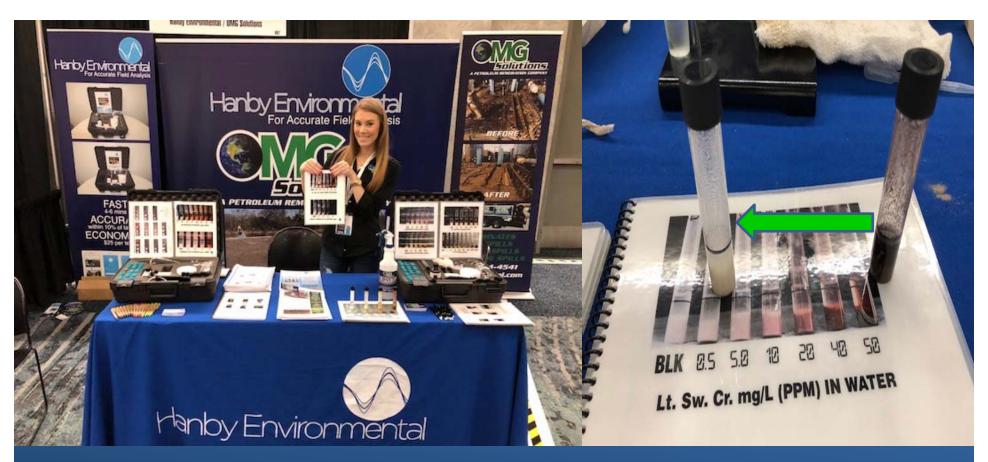
#### **Typical Water Test Results:**

### Clean Water, Contaminated Water to <u>48.5</u> ppm, Reduced to <u>7.7 ppm</u> by One Treatment

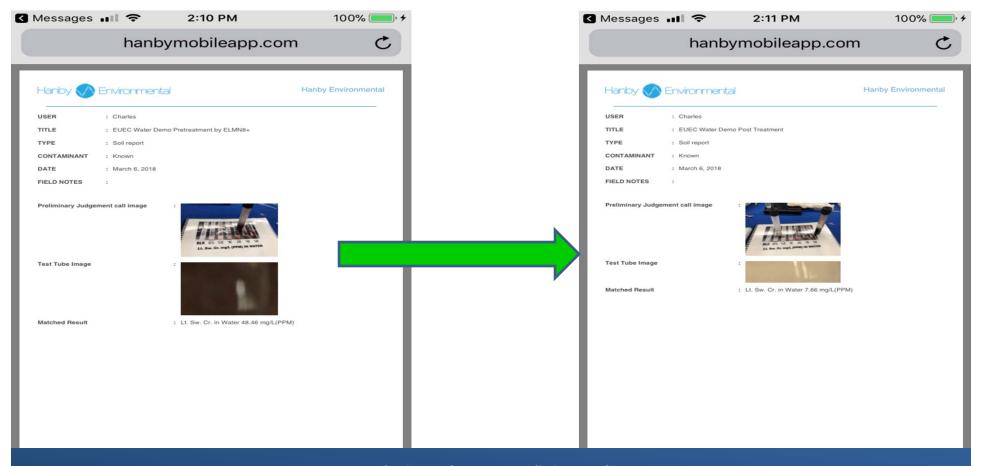
#### **Water Treatment Validation Results**

48.5 and 7.7 ppm

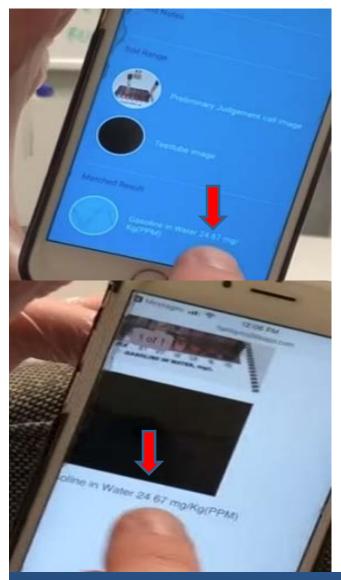
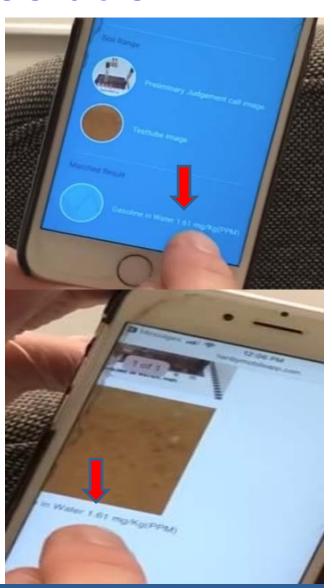
#### **Validation Test of The Solution**

**From 24.67 ppm**

Reduced to 1.61 ppm

By One Treatment of ELMN8+

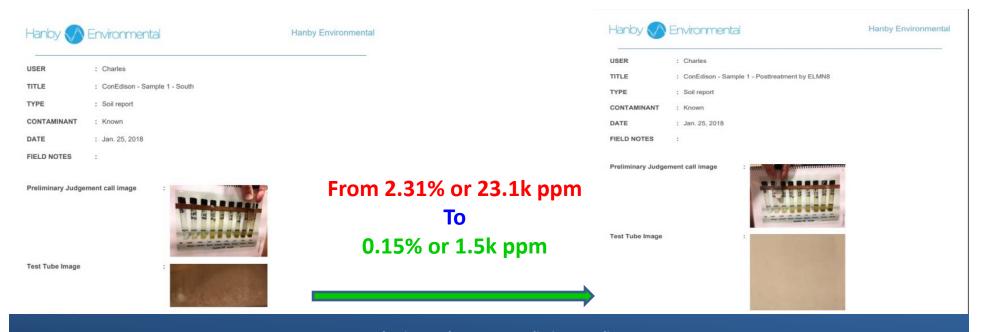
**Soil Sample 1 - South** had a beginning contamination level of 2.3% or 23k ppm reduced to 0.15% or 1.5k ppm after a single application of OMG's product ELMN8.

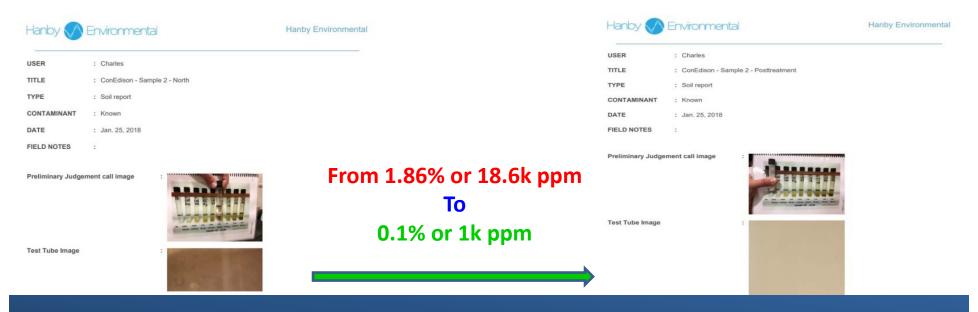
**Soil Sample 2 - North** had a beginning contamination level of 1.86% or 18.6k ppm reduced to 0.1% or 1k ppm after a single application of OMG's product ELMN8.

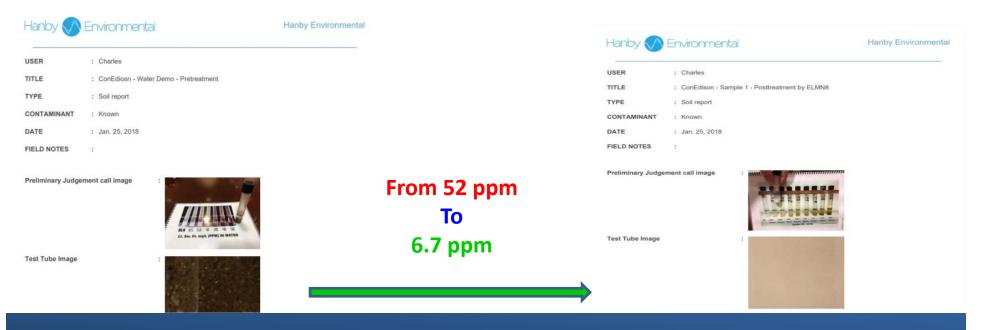
**Water Sample** - had a beginning contamination level of 52 ppm reduced to 6.7 ppm after a single application of OMG's product ELMN8+

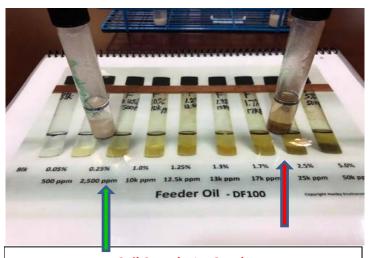
Soil Sample 1 - South

Pre (23k ppm) and Post (1.5k ppm) Treatment by ELMN8

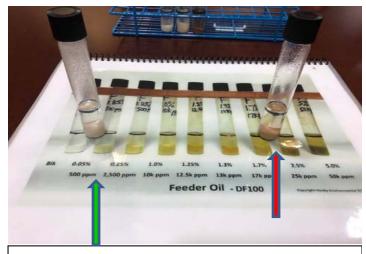
Soil Sample 2 -North

Pre (18.6k ppm) and Post (1k ppm) Treatment by ELMN8

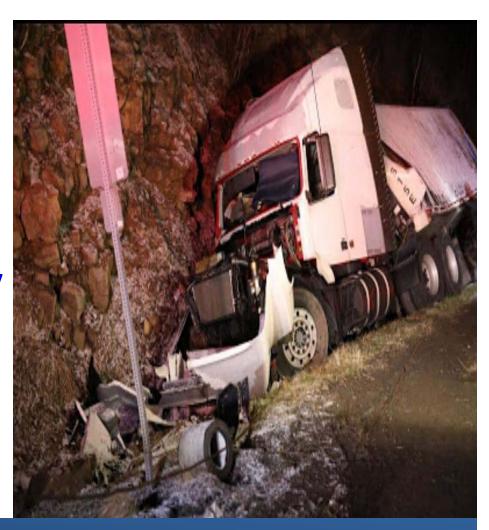
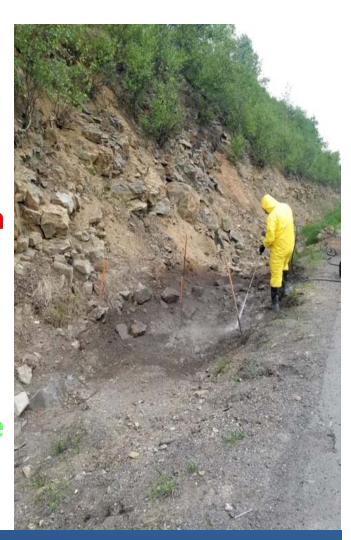
- JRL Emergency's Michael Litwak of Pennsylvania Responded to A Diesel Spill in Tough Conditions.
- The 18 Wheeler was in the Ditch Between The Road and a Mountainside.
- The PA DEQ told Him to Find A Solution Without Digging Which Would Probably Cause A Landslide.
- He Implemented The New Remediation Paradigm Utilizing A Combination of Surface Spraying Without Tilling and Injection and Migration.

- Using Both His Field Test Kit and Mobile App, He Was Able To Document The Beginning Contamination Level of 68k ppm.
- After Two Treatments He Was Able To Document That The Diesel Contamination Had Been Reduced to 332 ppm.
- They Used A High Pressure Jet To Agitate and Break Up Soil and Sprayed for Migration Afterwards.
- At 332 ppm, He Sent Samples Off for Lab Analysis, All The While The Samples Were Still Oxidizing.

- The Lab Results
   Came Back Non Detect for TPH
   and BTEX.
- Michael said, ""We were able to test, apply, and get out of harms way faster with Hanby's quick results and OMG's quick application."

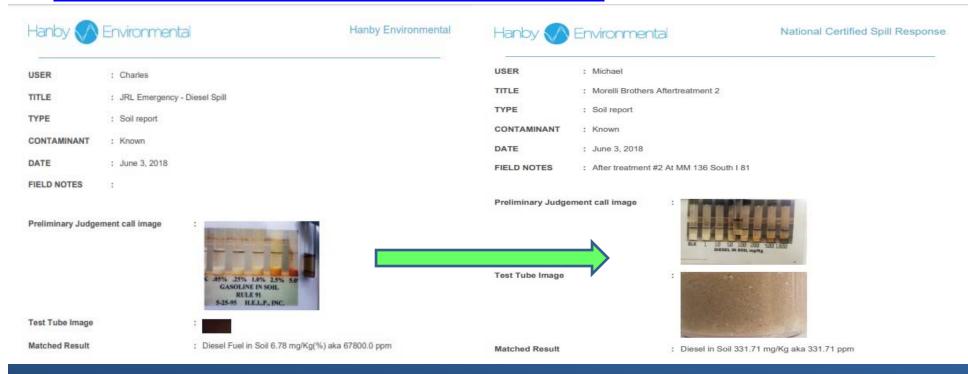
- PreTreatment of 68k ppm:
- http://hanbymobileapp.com//media/pdf/report830.pdf
- Post treatment of 332 ppm:
- http://hanbymobileapp.com/media/pdf/report829.pdf

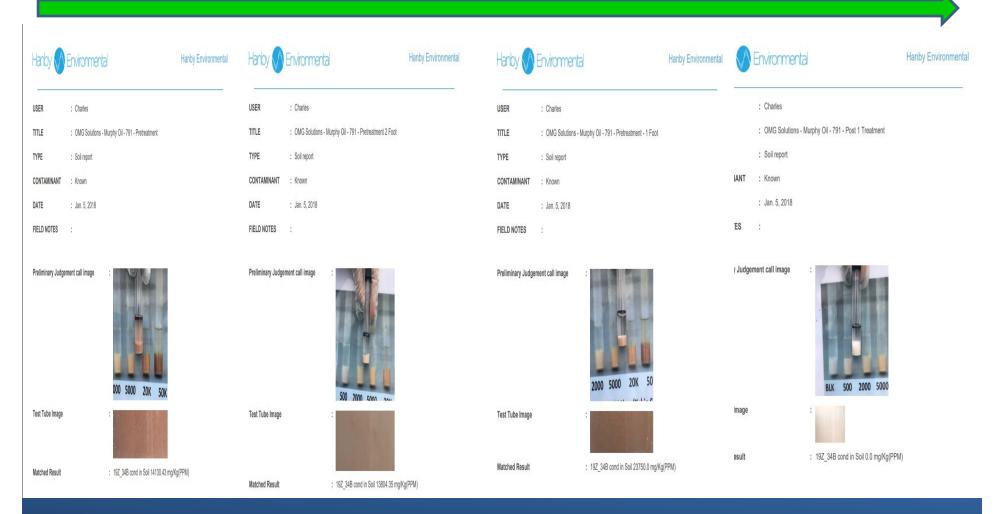
# Hanby Mobile App Report Results From 14.1k, 13.8k and 23.8k to 0 ppm

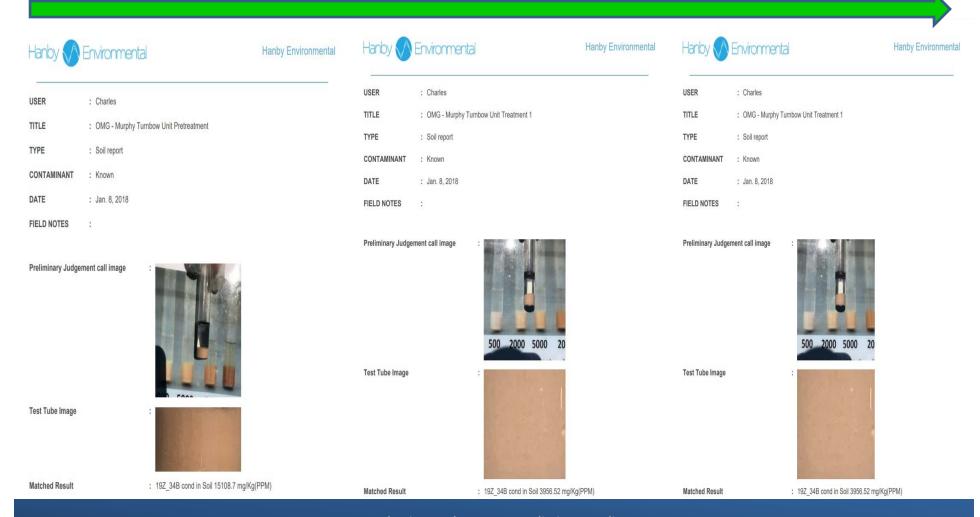
# Hanby Mobile App Report Results From 15.1k to 3.6k and 4.7k ppm

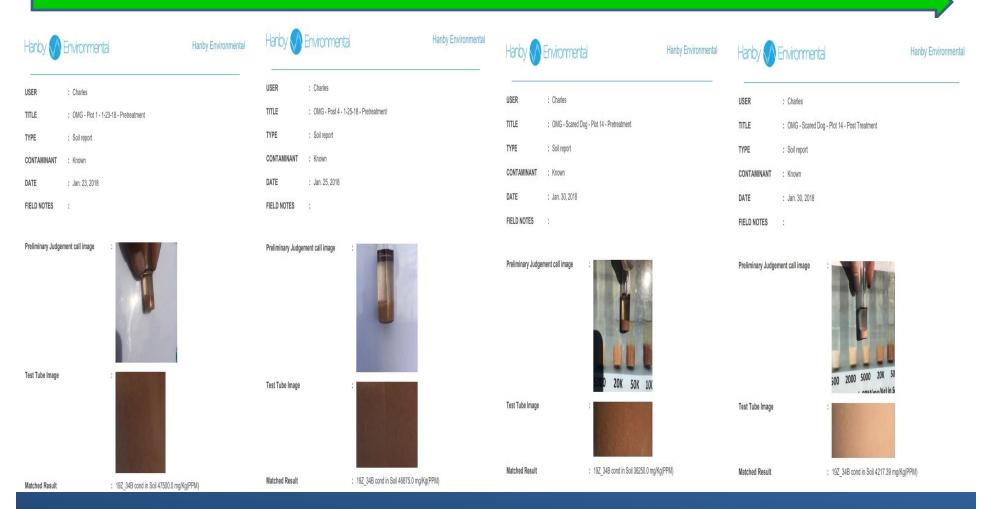
# Hanby Mobile App Report Results From 47.5k, 46.9k and 36.3k to 4.2

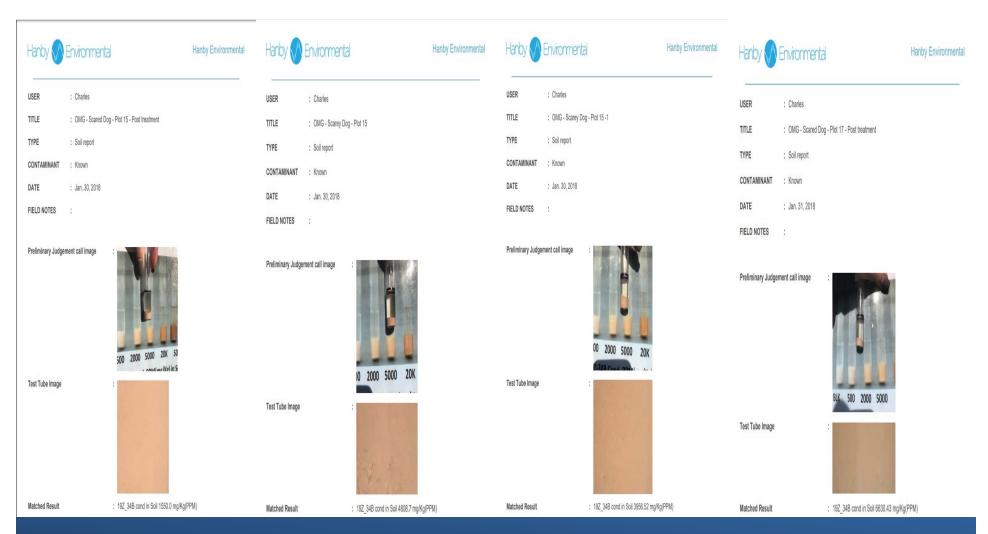
Some Final Test Result 1.6k, 4.6k, 4.0k and 6.6k ppm
