Forensic Chemical Analyses Coupled with Detailed Site and Water Column Observations Used to Locate the Primary Cause of a Persistent Sheen off Louisiana's Coast

Part 1: Tiers 1 and 2

Edward B. Overton, Louisiana State University

03/08/2017

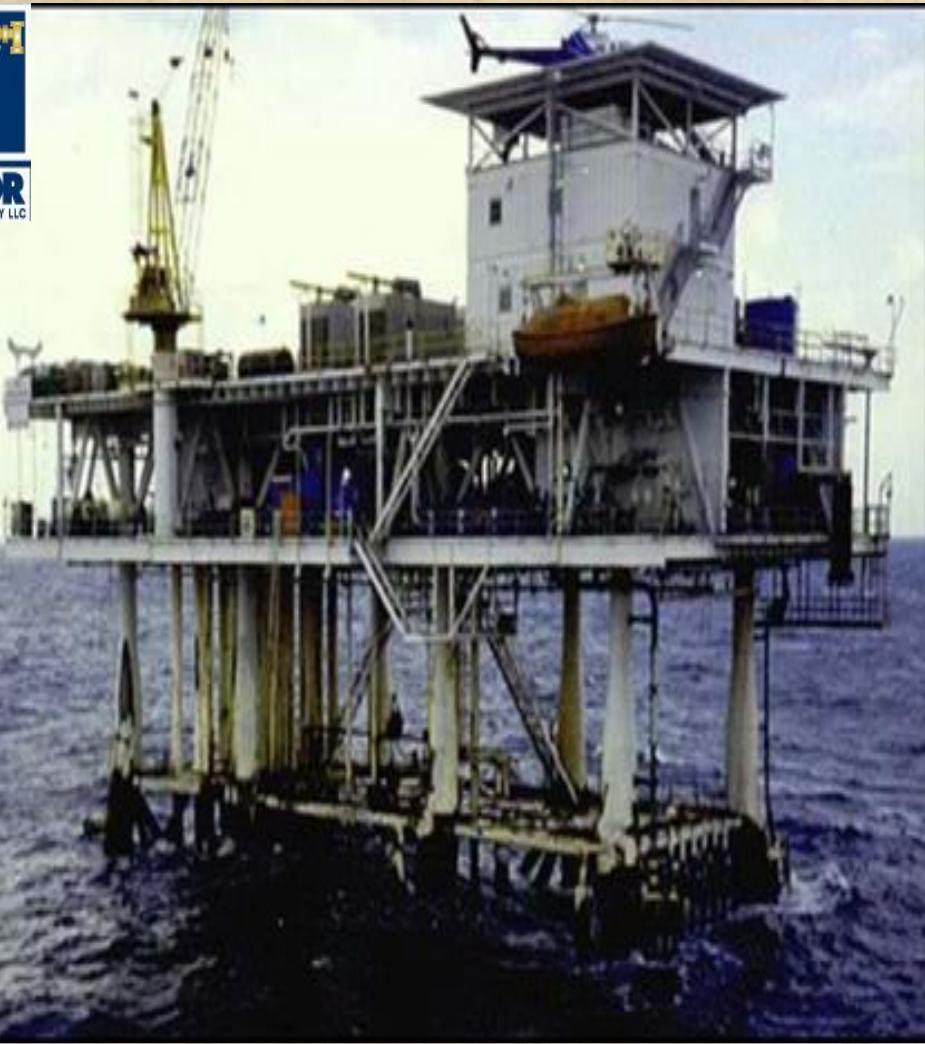
In 2004, Hurricane Ivan passed directly over Block MC20, causing a mud slide that toppled this Taylor Energy Platform

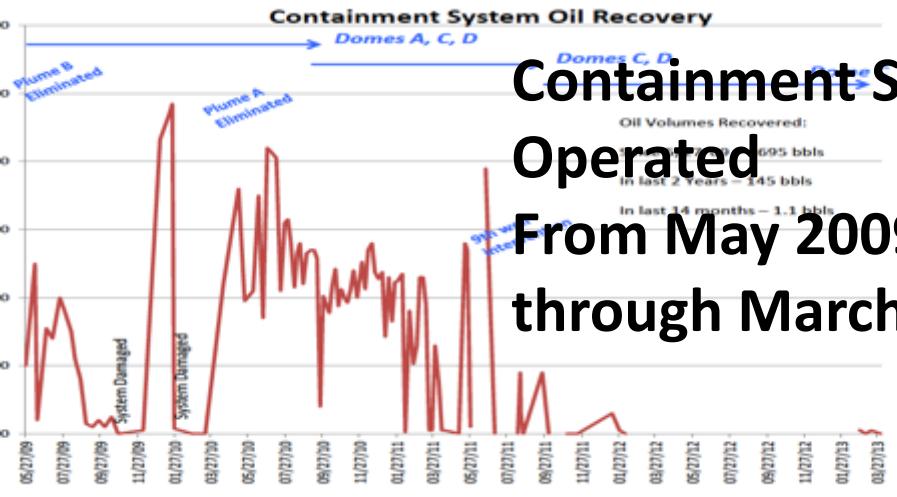
**Containment System
Operated
From May 2009
through March 2013**

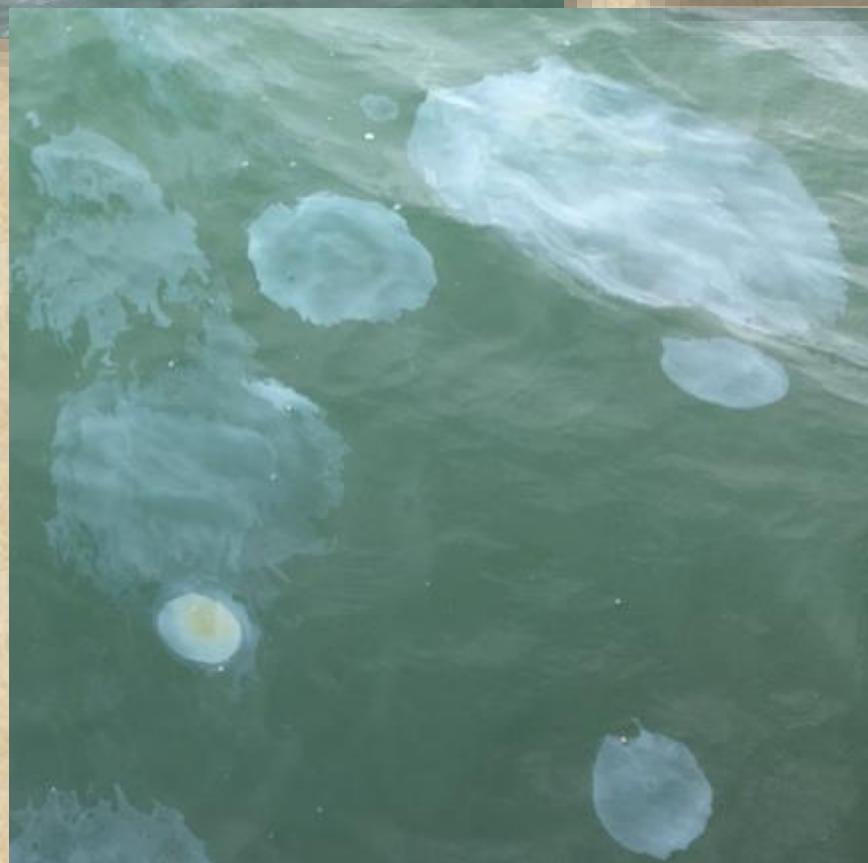
Looks of the Sheen
March 8, 2017

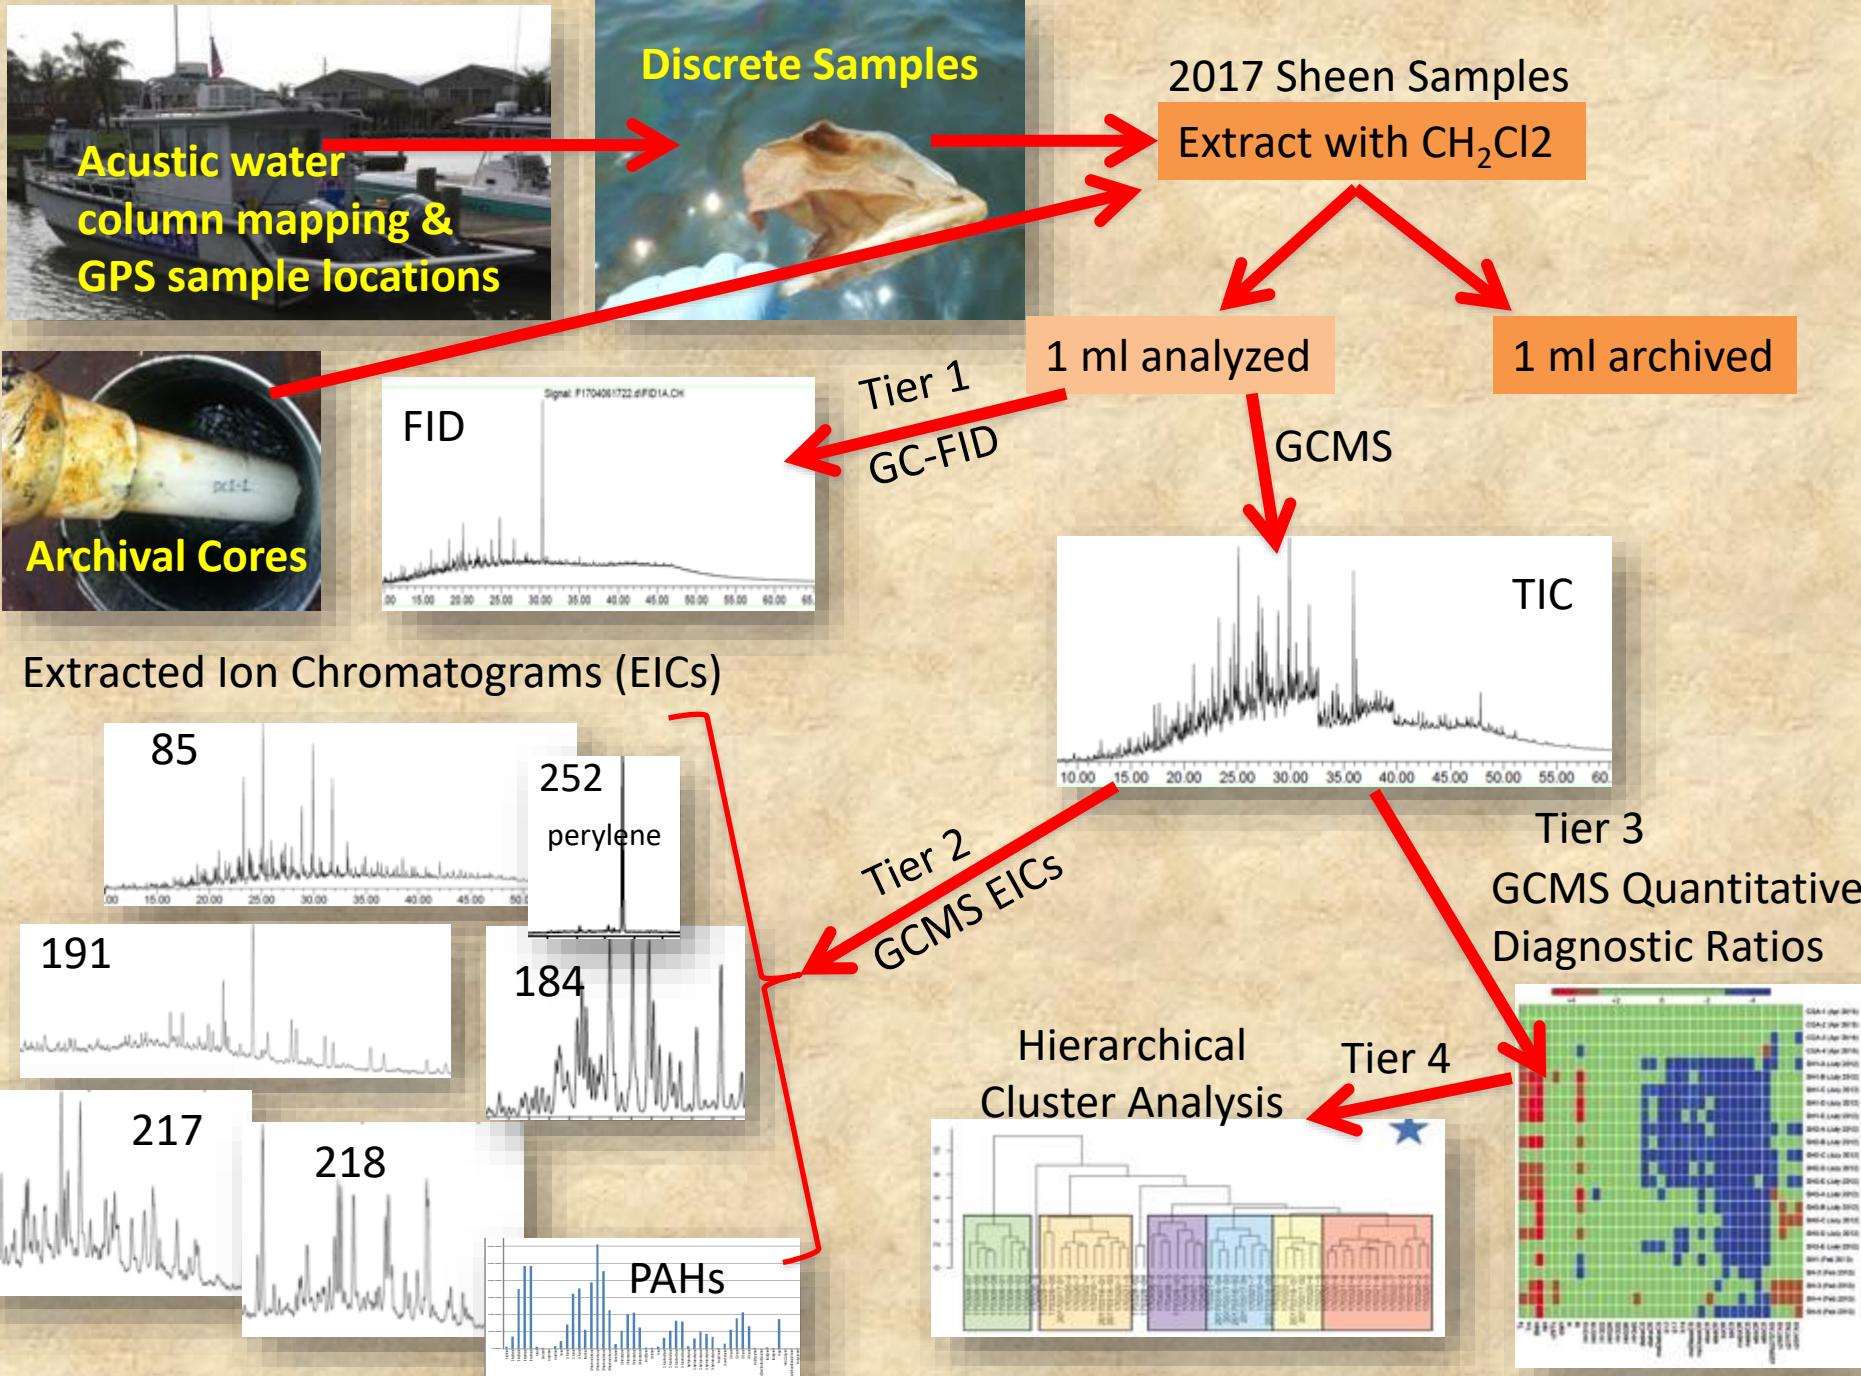
GC/GCMS Analytical Data

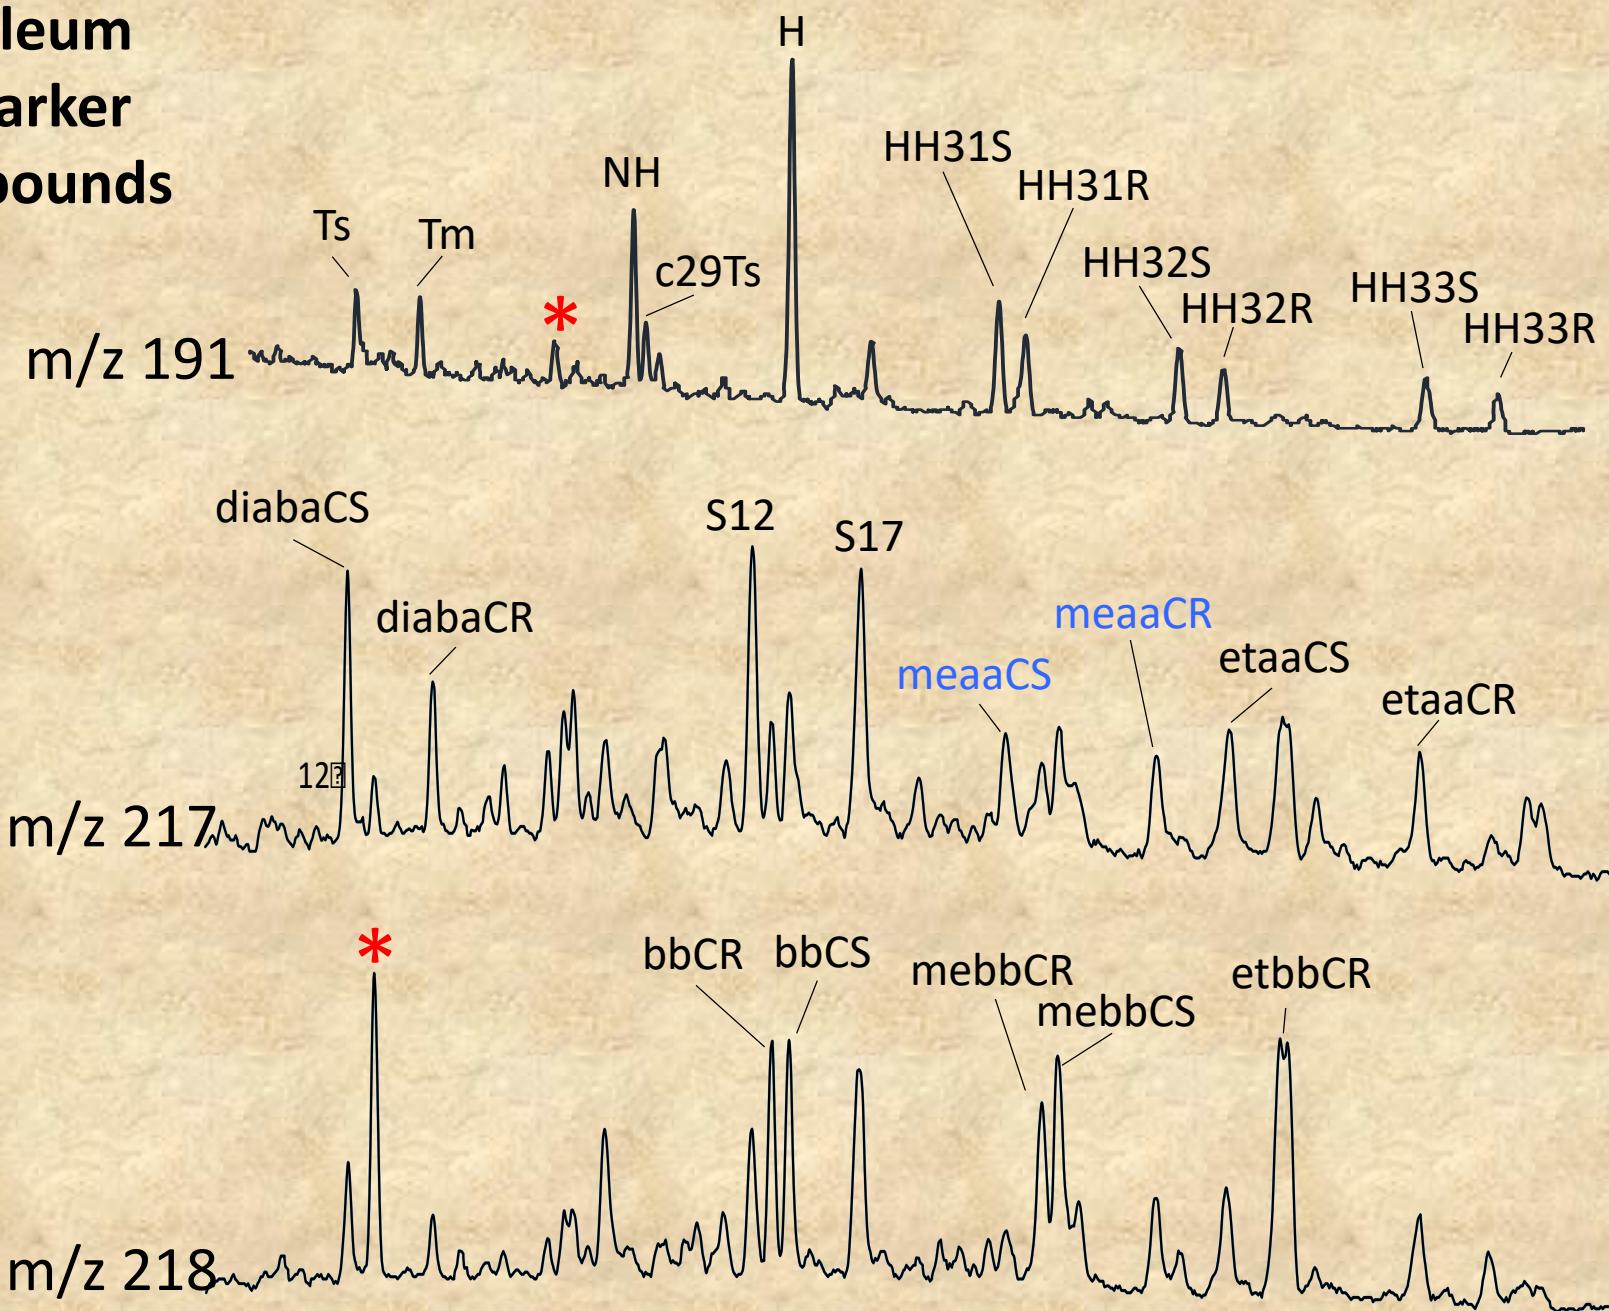
Looking for Differences and Similarities (binning)

sheen samples collected the same day

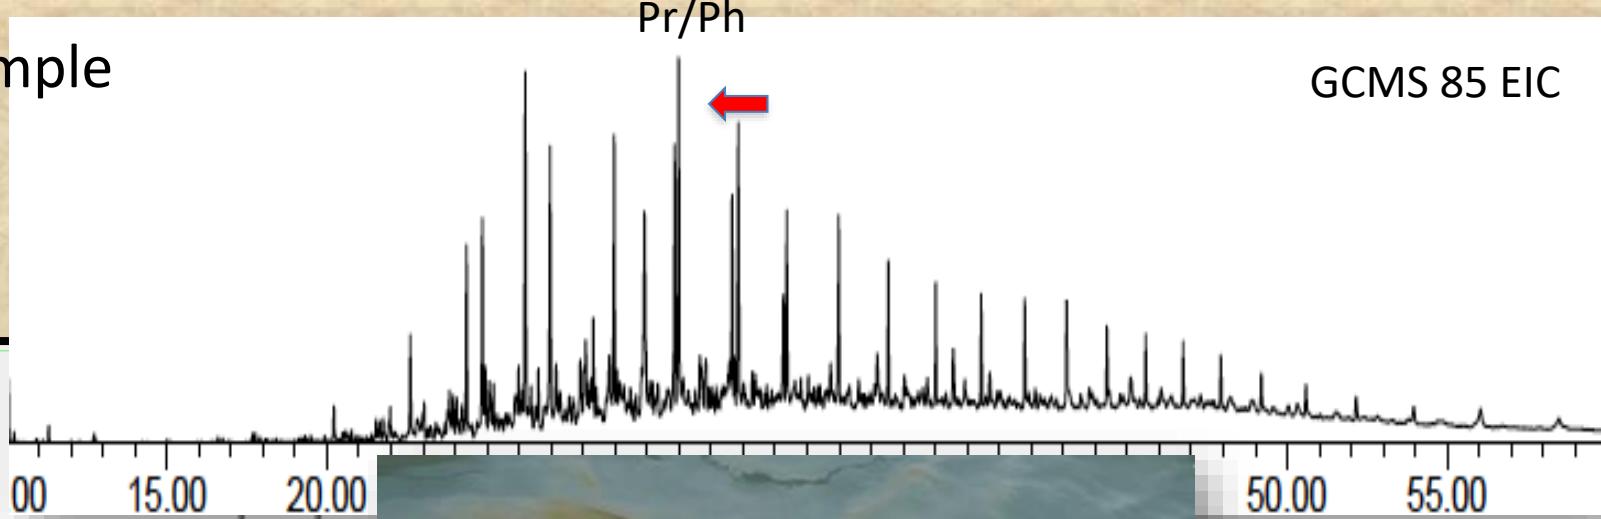
#170308-01

Sheen Sample
3/8/17

GCMS 85 EIC

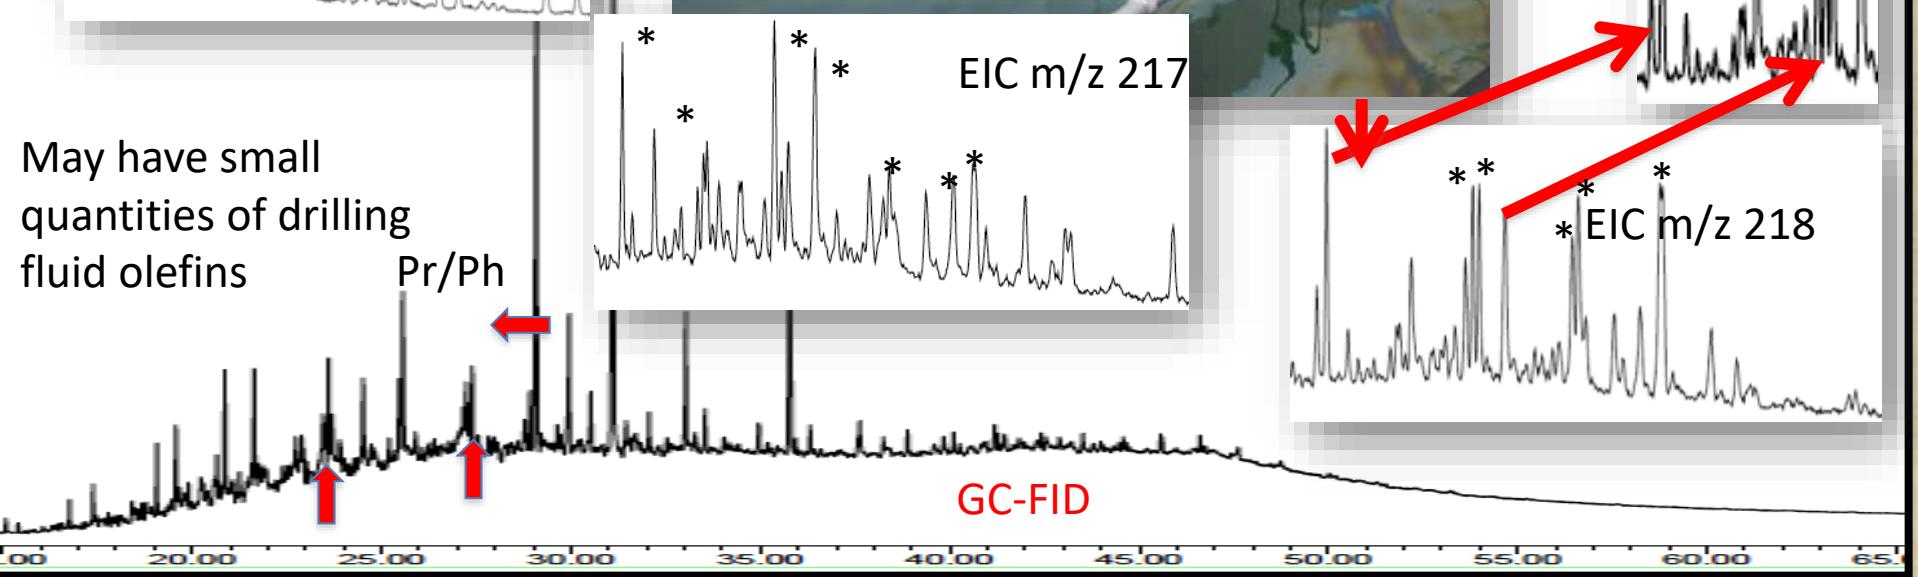
May have small
quantities of drilling
fluid olefins

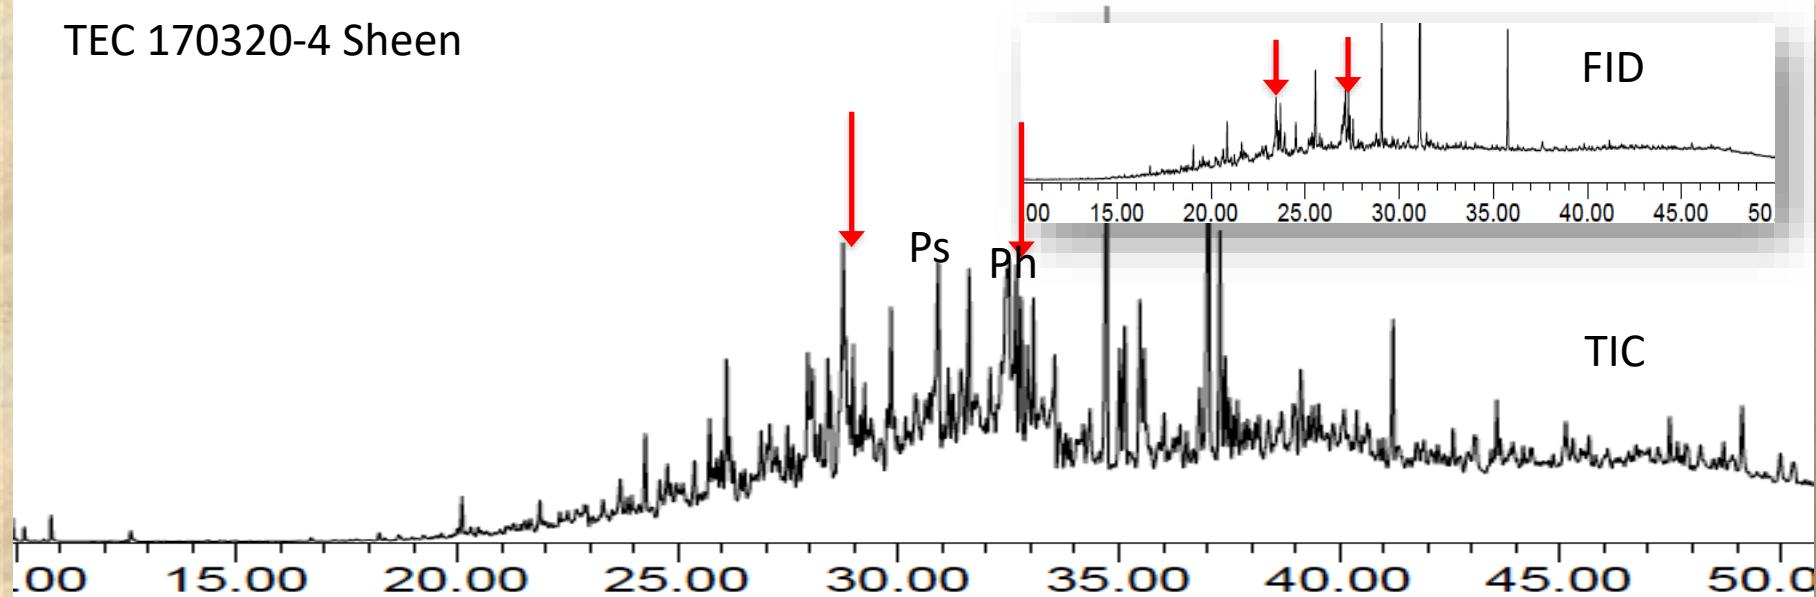
TEC 170320-4 Sheen

GC-FID

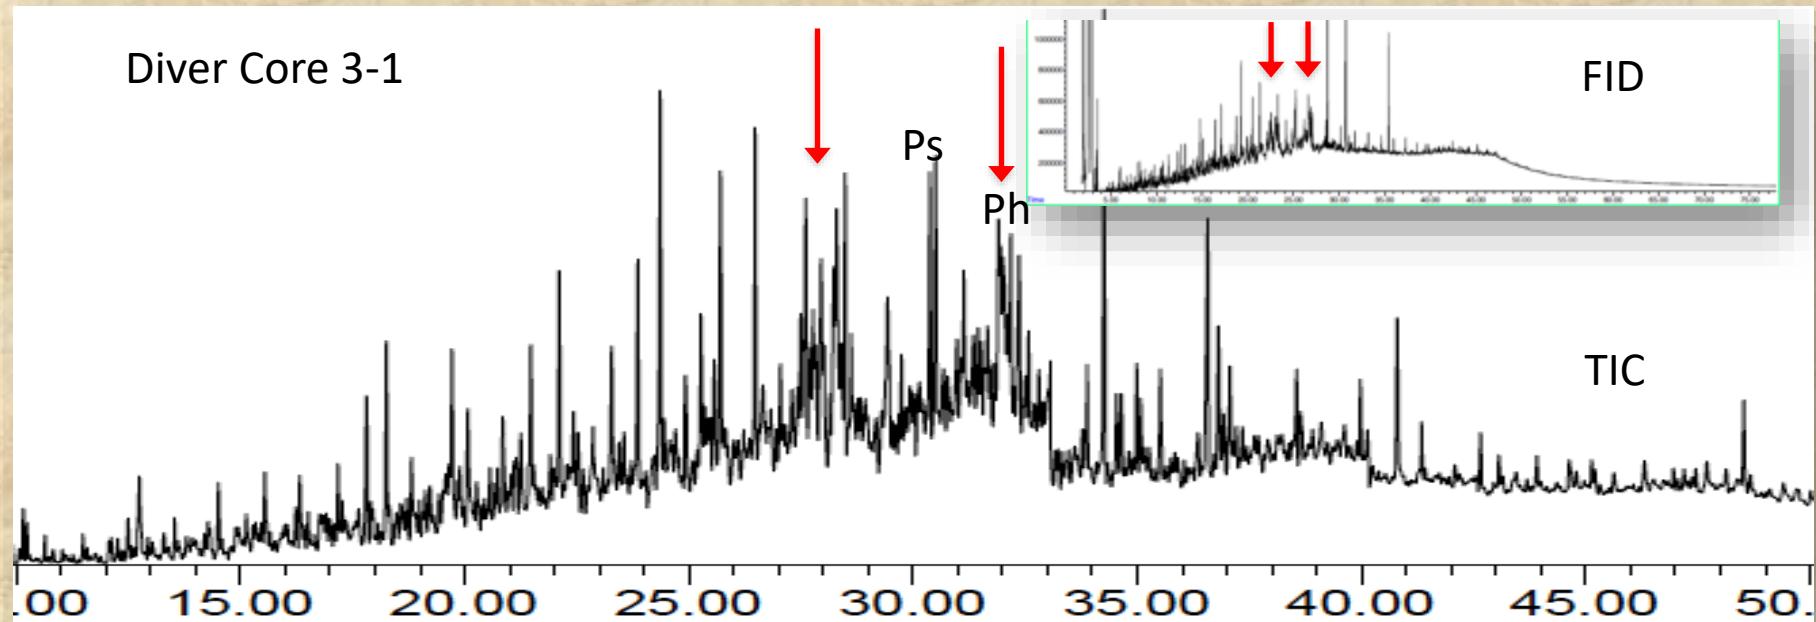
Diver Core 3-1

Samples with evidence of contamination from drilling mud olefins

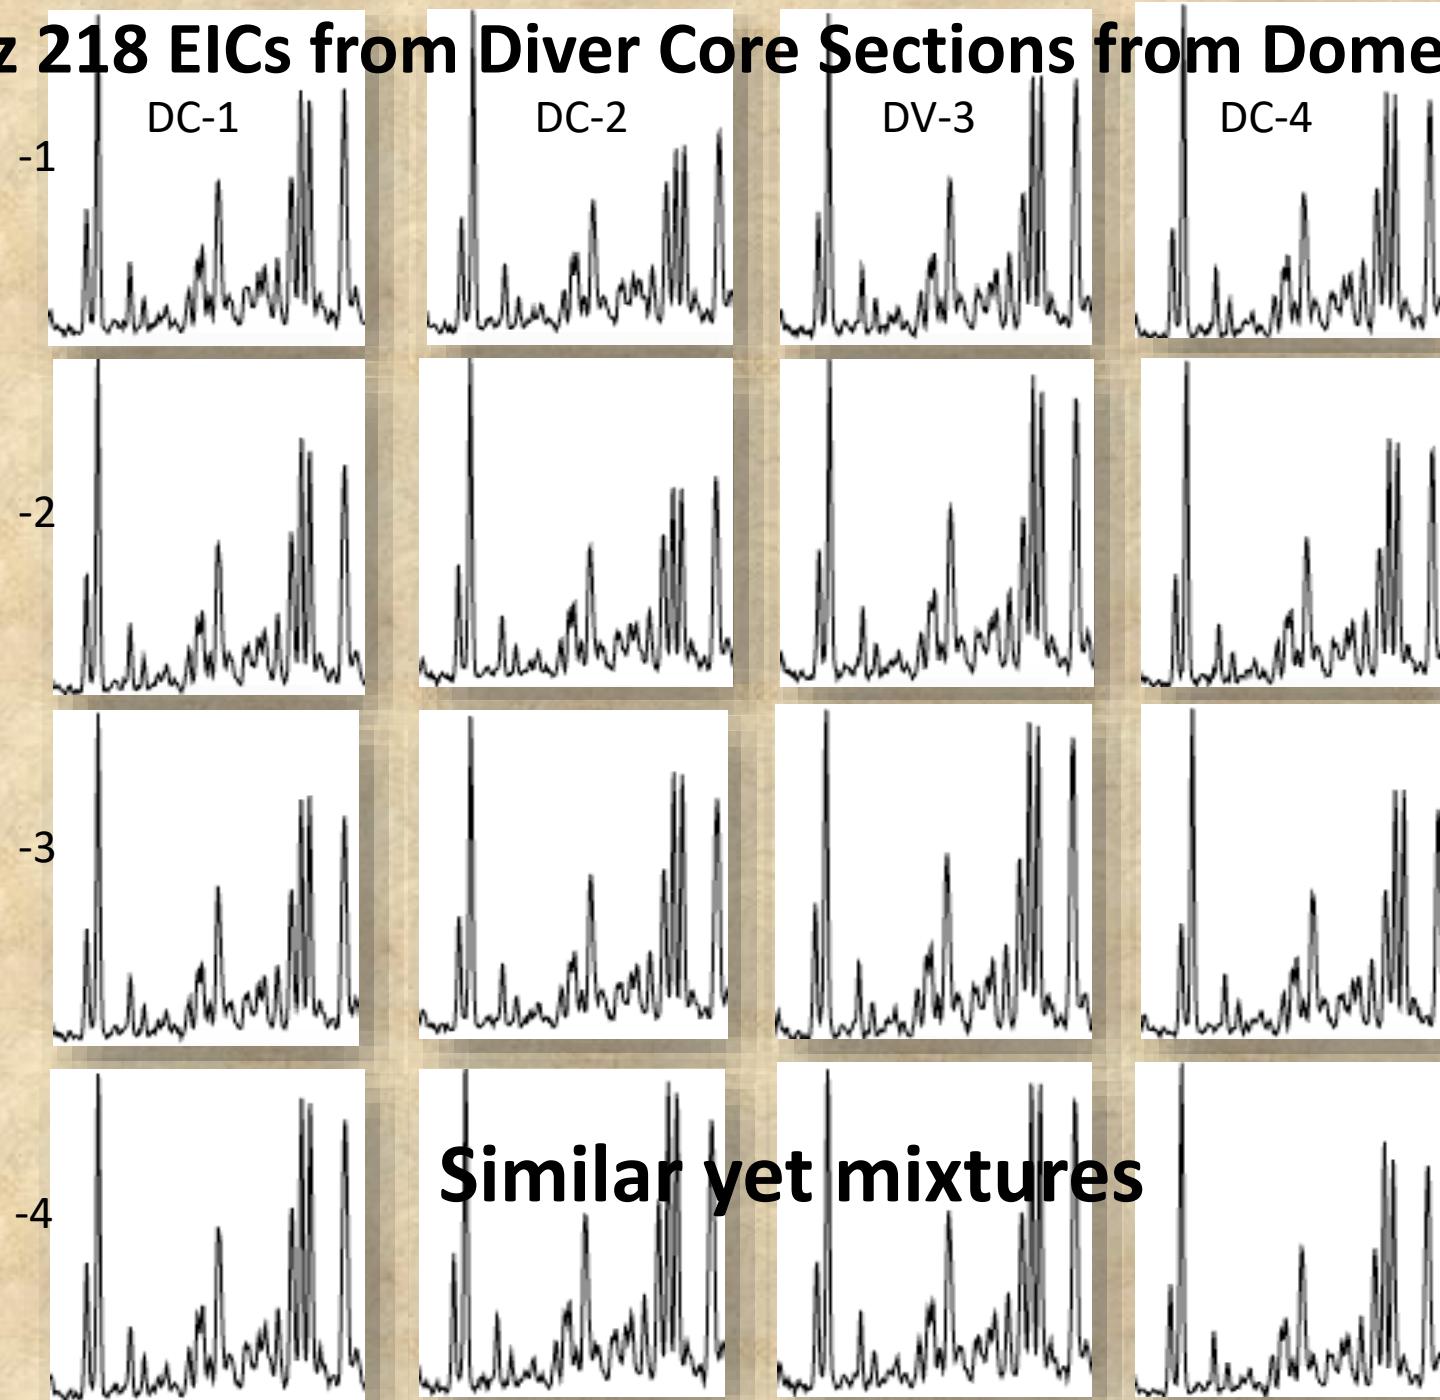
m/z 218 EICs from Diver Core Sections from Dome C Area

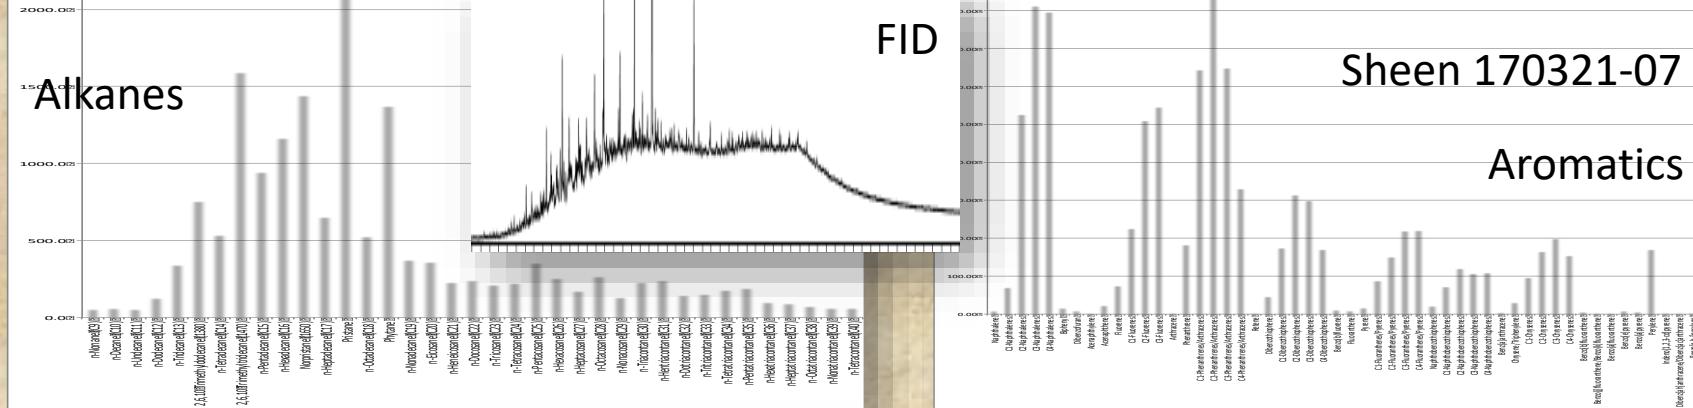
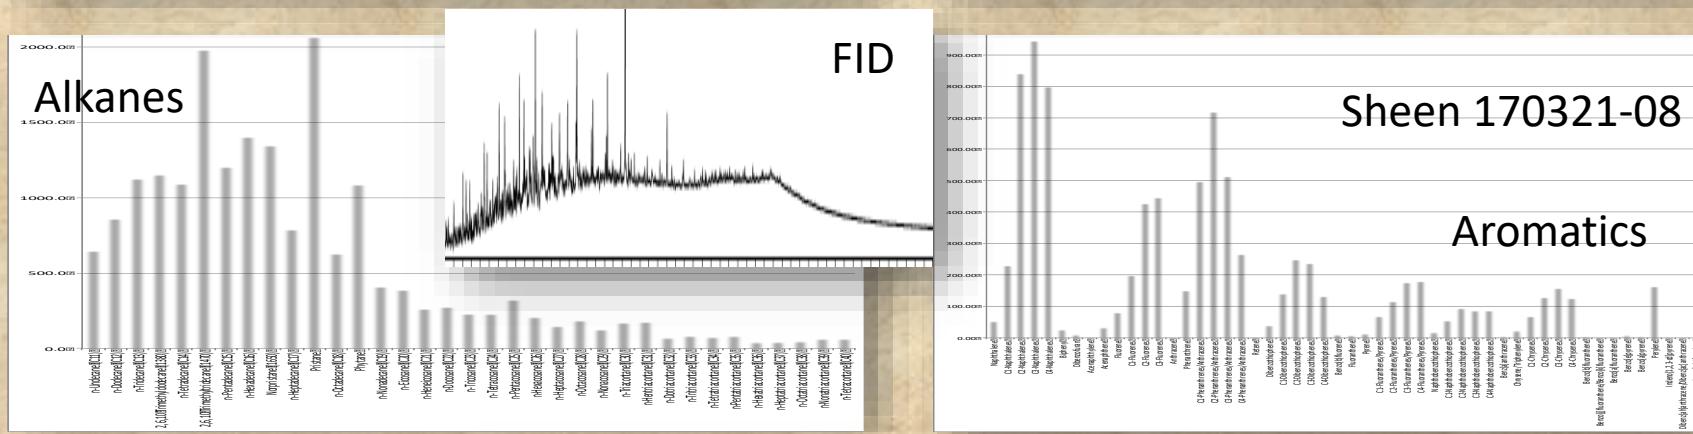
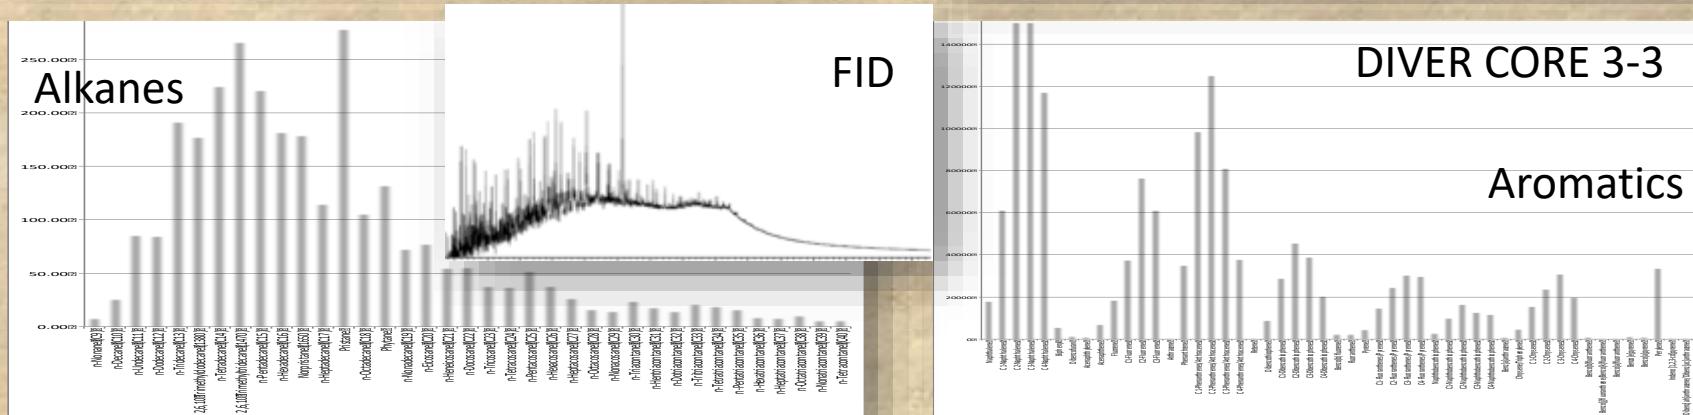
Slight Weathering of Surface Sheens compared to Diver Cores

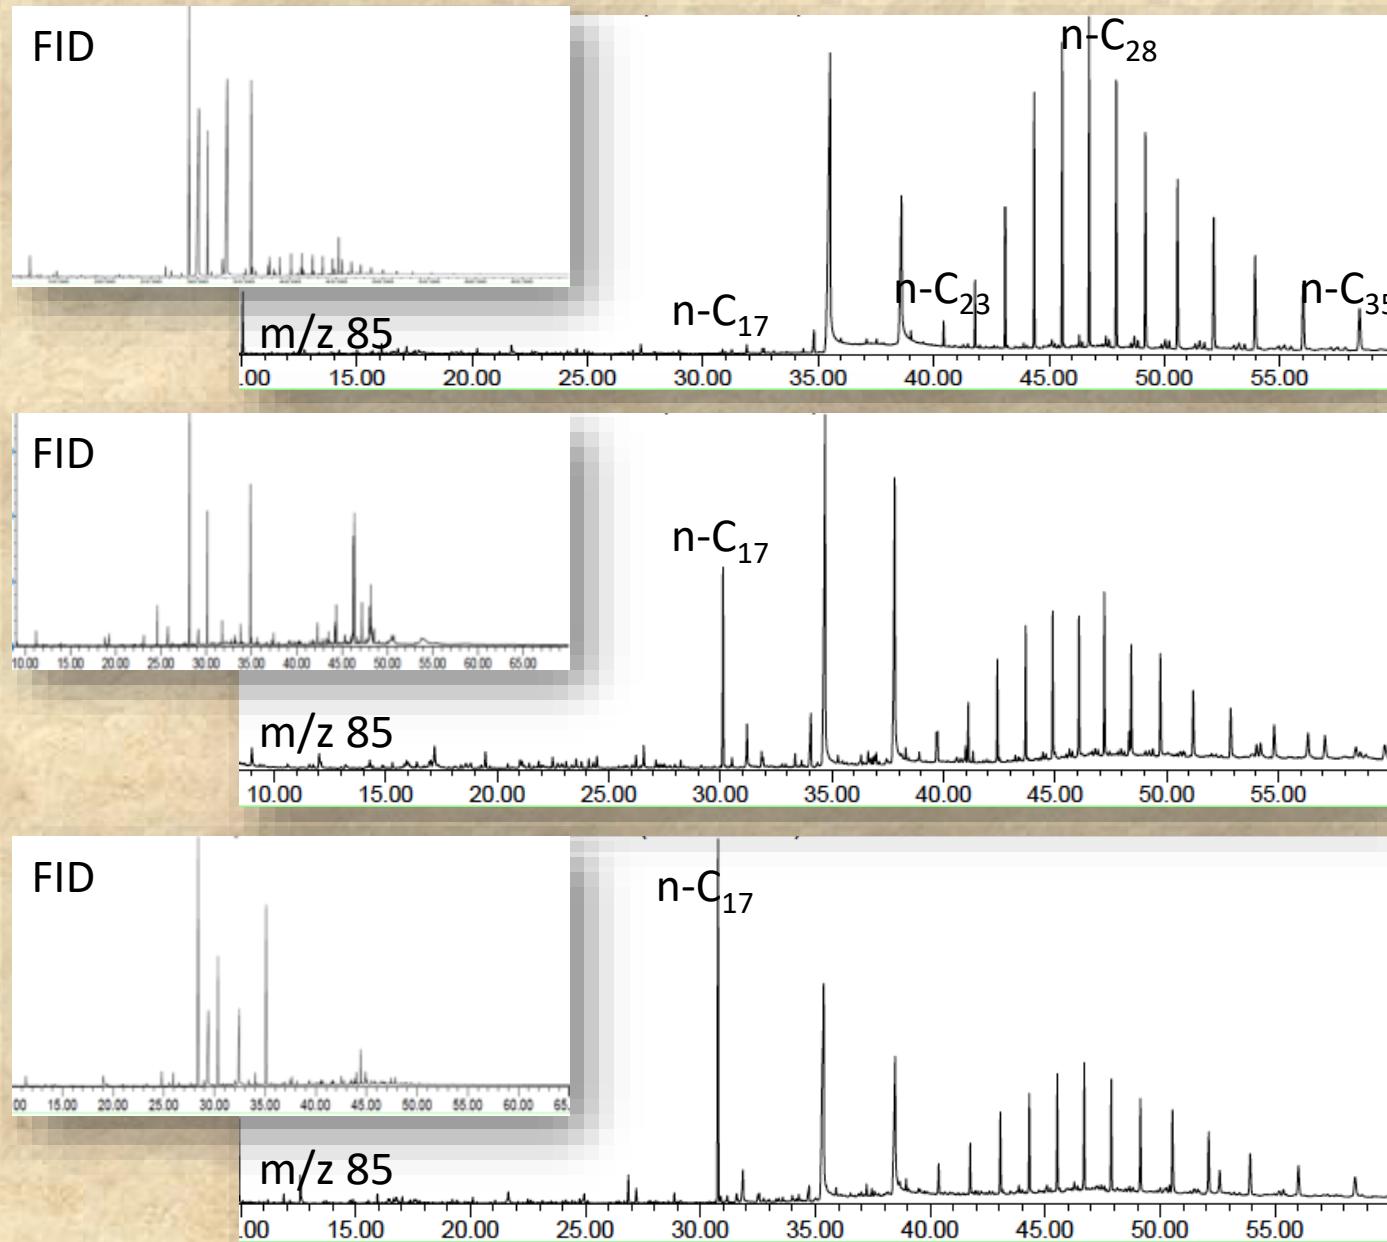
2017 Sheens containing no Biomarker Compounds
